Causes and environmental impact of the gold-tailings dam failure at Karamken, the Russian Far East

Vladimir E. Glotov^a, Jiri Chlachula^{b,c,*}, Ludmila P. Glotova^a, Edward Little^d

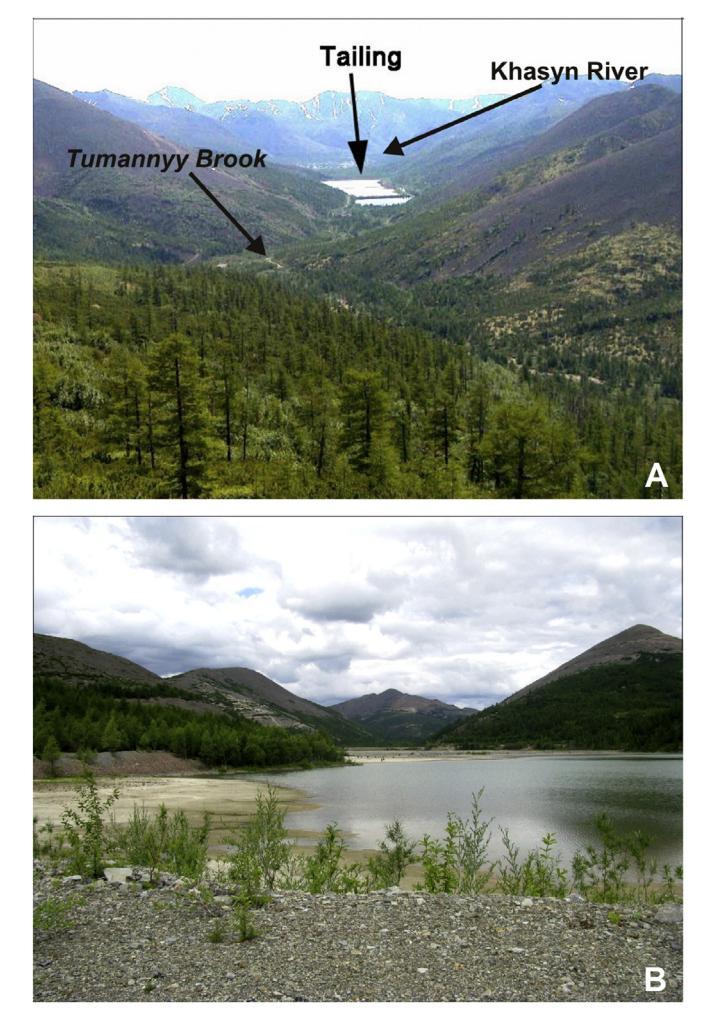
Fig. 2. A. An oblique aerial view of the Karamken gold-mineral tailings waste reservoir prior to the dam failure on 29.08.2009. B. View from the terminal part of the right dam crest wall (sandy-gravelly embankment). (photos by V.Ye. Glotov).

The main tailings pond measured 1200×230 m, and the dam wall was 28 m high with the crest length 320 m and width at the base of 10 m. About 8 m below the levee crest, the structure reached 6 m thickness (Fig. 2B). The unconsolidated loosely-pilled up levee with a certain water-filtering capacity was built from the local alluvial sandy-gravelly deposits of the Tumannyyy Brook and mountain-slope talus debris extracted in a nearby quarry (Fig. 2B). The technogene water-saturated wastes accumulated over the time of the gold-processing operations in the frontal part of the downstream dam to form a 7–8 m thick sedimentary body.

The thixotropy factor activated in the tailings dues to heavy mechanical (bulldozing) operations on the frontal dam crest (Figs. 2B, 7B). Saturated tailings compacted into a solid partly submerged mass with an enhanced shear-thinning ratio are susceptible to vibrations and gravity-flow processes analogously as in mudflows (Perret et al., 1996). After cessation of mechanical actions they normally return to a dense state with the expulsion of water (Seng and Tanaka, 2012). But under the intensive and protracted rainfall in the Karamken area, the backfill material of the dam wall mixed with the liquefied ore-processing waste and thinned to an average density of slurry ($\sim 1.2 \text{ t/m}^3$). The volume of this material is estimated at \sim 280,000 m³ with a total mass weight of ~340,000 tons. The lateral pressure of the drifting saturated mineralwaste depositional mass with increased kinematic energy in conjunction with the progressively water-percolated levee body generated the ultimate dam-failure scenario (Fig. 5B) resulting in the catastrophic mud flood into the Khasyn River.

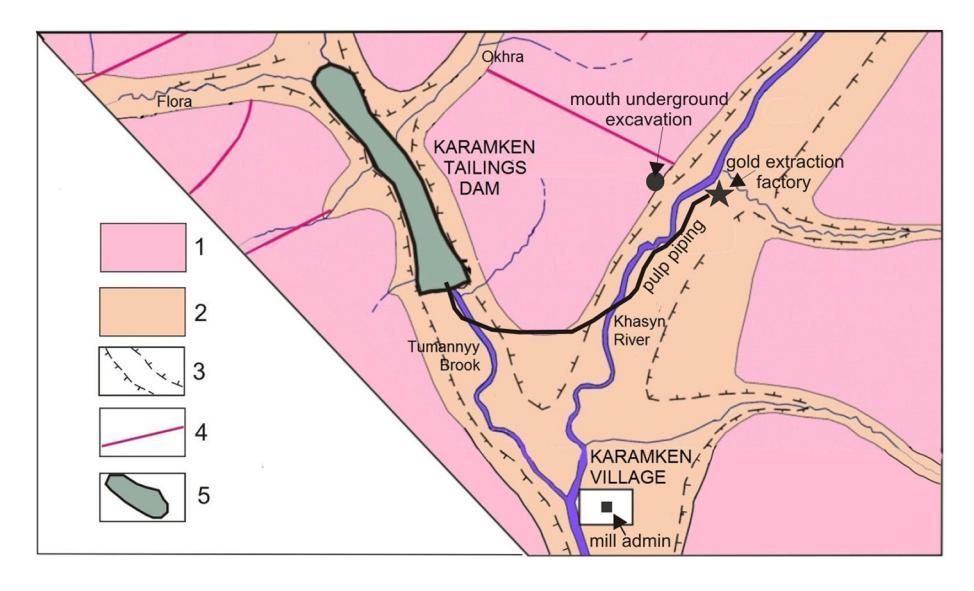
Fig. 3. Geology, cryology and hydrology of the Karamken tailings dam setting with a schematic technical mineral-processing base. Legend: 1 – Upper Cretaceous surficial geology (the surrounding mountain topography); 2 – Quaternary deposits (valley floodplains); 3 – limits of permafrost thaw zone; 4 – tectonic faults; 5 – the original tailings dam waste fillings.

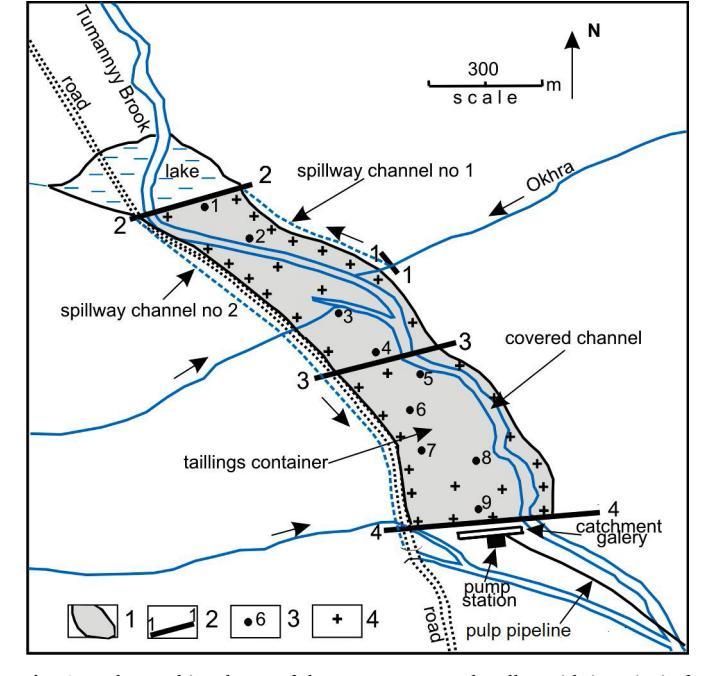
Fig. 4. Hydrographic scheme of the Tumannyy Brook valley with its principal tributaries (the Flora and Okhra streams) and location of the Karamken plant technical management facilities. Legend: 1 – tailings dam outer limits; 2 – dam construction alignments (1–1 Okhra Stream; 2–2 Tumannyy Brook; 3–3 central across the tailings dam; 4–4 terminal barrier); 3 – pulp sampling sites; 4 – surficial monitoring/sampling sites.

From the constructional viewpoint, the weak spot was the spillway channel no. 2 (Fig. 4). This spillway goes along the right slope of the valley at 0.0015° for a total length of 1360 m, average width of 8 m, and average depth of 2.8 m; the spillway was engineered for a maximum flow capacity of 48 m^3 /s. The tailing plant spillway was built 2 years prior to the plant initiation. Originally, the channel was planned to be lined by concrete slabs. However, in the first year of the operation, there was an uneven and uncontrolled cryolithic collapse at the bottom of the channel in the head pickets for about 30 m. In December 1976, subsidence progressed, forming a trench 7 m deep that exposed large (up to 1 m) veins of underground ice, overlooked by preceding geoengineering survey due to insufficient number drill holes. A control trenching detected lenses of frozen peat covered by colluvial deposits testifying to active gravity slope creep processes. A decision was made to remove the frozen peat and ice wedges and replace the voids by gravelly filler to block expansion of underlying ice. To reduce pressure, iron slabs were placed along the channel instead of the concrete ones. Although the steel components were welded together, there was a channel tailings effluent leaking (up to 321/s) for a distance of 270 m

from the head picket. In 2000, the steel lining was removed by metal looters. The trim was subsequently restored, but was replaced by loose iron sheets. This contributed to an enhanced leakage of the channel no. 2. Fed by water from the spillway channel, deposits started to accumulate at the bottom of the embankment along pond perimeter. The total flow rate in the low-flow summer averaged 2801/s. Some water seeped into the submerged and liquefied tails, the rest accumulated on their surface within a shallow technogene lake.

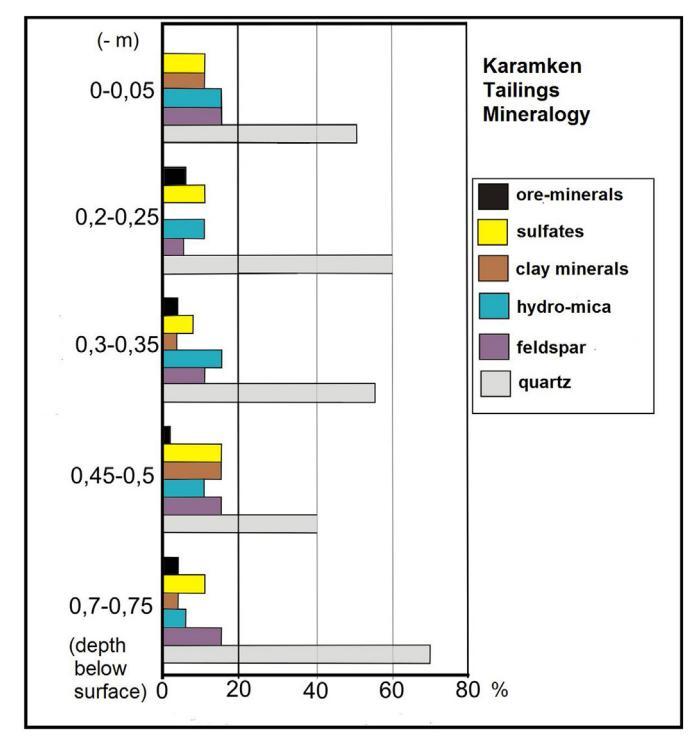
The analytical results show that the geochemical reactions leading to changes in the mineral composition of wastes contributed to an activated fine-grained (clayey) sediment formation. This process likely involved large surface-area reactions of plagioclase with oxygen and water, which triggered a widespread development of capillary water membrane. By capillary rise, water migrated to the front layer of the seasonal freeze-thaw zone, i.e. to the day surface, with increased evaporation during permafrost degradation and active layer expansion. Summer desiccation of the tailings surface led to formation of a whitish silty salt crust of 5–30 mm in thickness. In mineral composition, this included melanterite (FeSO₄·7 H₂O), jarosite (KFe₄ + [(OH) 6·(SO₄) 2], halotrichite (FeAl₂ [SO₄] 4·22 H₂O), gypsum (CaSO₄·nH₂O), and hydromica and kaolinite (Table 1).

Fig. 5. Normalized mineralogical composition of the Karamken tailings in the original dam.

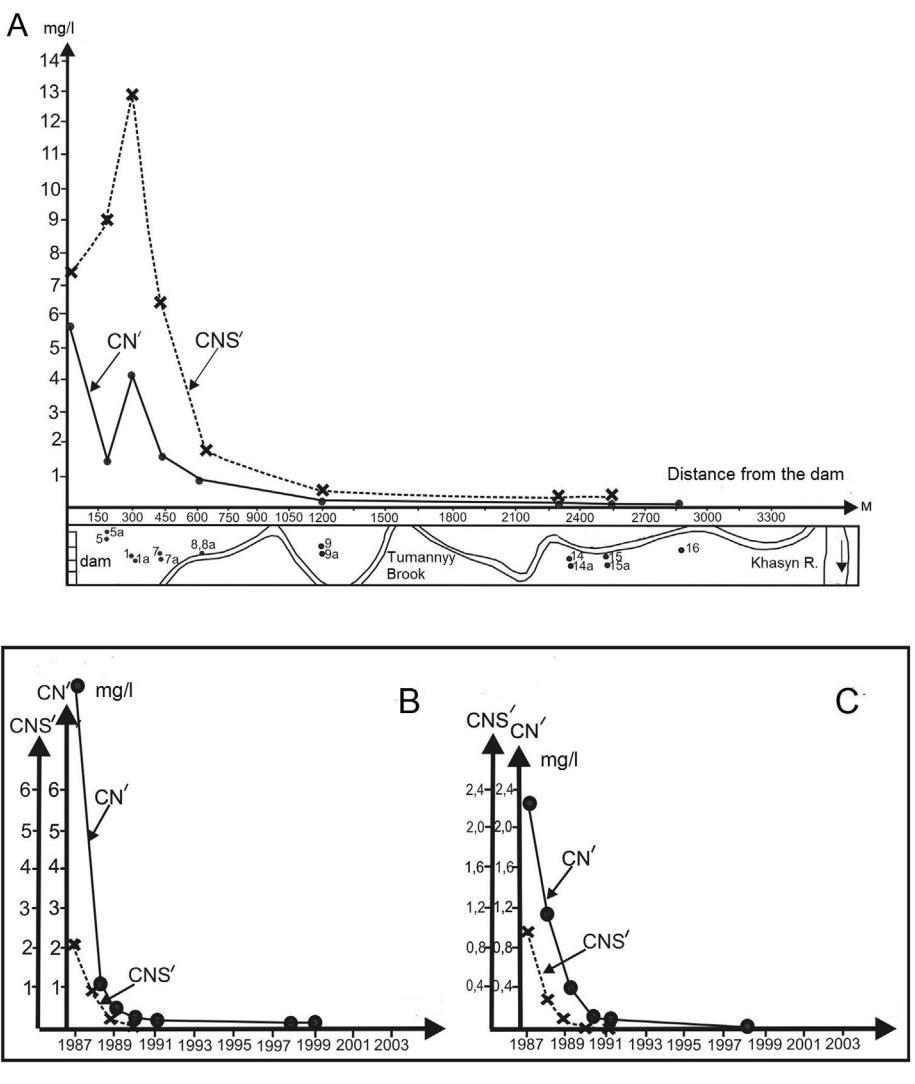
In 2007, cyanide and thiocyanate-rhodanide (CN^{-1}/SCN^{-1}) were at maximum of ~300 m downstream of the dam $(5/13 \text{ mg/dm}^3)$, but progressively decreasing to ~0.05 mg/dm³ (Fig. 6A). The latter value complies with the present Russian drinking water norms SanPiN 2.1.4.10749–01 $(CN^{-1} \ 0.035, SCN^{-1} \ 0.1 \text{ mg/dm}^3)$ as well as the national fishery norms $(CN^{-1} \ 0.05, SCN^{-1} \ 0.15 \text{ mg/dm}^3)$ (Federal Agency for Fisheries, 2010). Monitoring during plant operation and after its closure (1987 to 2003) provided evidence of a rapid decrease of both toxicants in the first years (Fig. 6B-C). These values correspond to the European Union 2006/44/EC normative physical and chemical

Fig. 6. A. Spatial concentration of cyanide (CN) & thiocyanate (CNS) (1987). The below scale shows the distance (m) from the tailings dam wall further downstream the Khasyn River; B–C. Temporal concentration changes of cyanide (CN) and thiocyanate/rodanite (CNS) at the tailings dam wall (B) and a 20 m-drilling well 150 m downstream (C) for the 1987–2004 period.

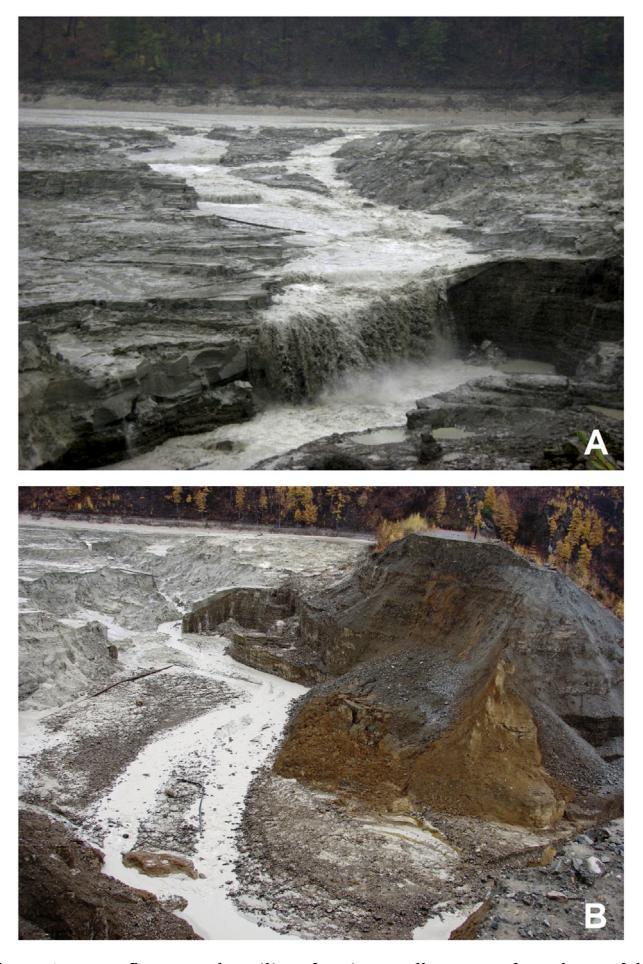
Fig. 7. A. Water flow over the tailings forming small caverns after release of the accumulated pulp after the Karamken dam breakage (situation 1 day later, on August 30th, 2009, 12:00); B. Tailings after breakage of the dam levee with the exposed pulp depositional masses.

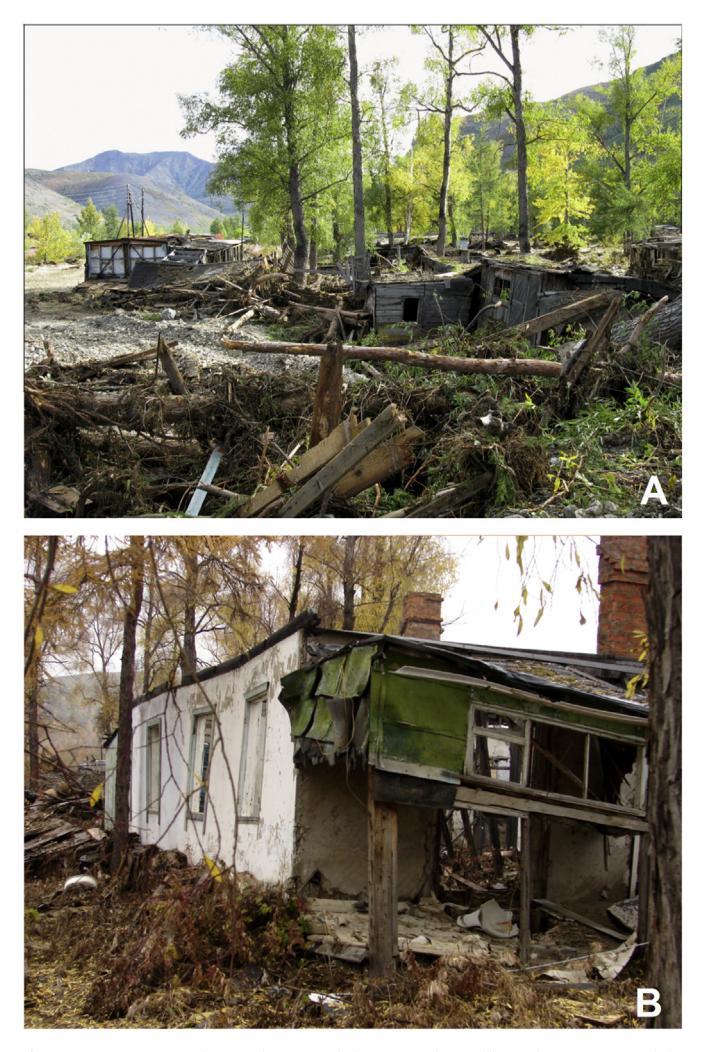
The dam levee failure in the early morning of 29.08.2009 generated a slurry flow destroying the nearby village and a forest plantation in the Khasyn and Karamken floodplain. Two local villagers drowned, about 25 households and farm buildings were severely damaged. Vegetation downstream along the lower reaches of the Khasyn River valley was almost completely washed away. The spill caused a major water contamination by residual toxic elements and the suspended tailings pulp harming the local fishery and sources of drinking water. The total property loss, including the following mitigation costs, amounted to \sim 150 Mln RUB (\sim 7.5 Mln USD). The paper discusses the causes and consequences of this environmental catastrophe.

Fig. 8. A-B. Destroyed taiga forest and the Karamken village downstream of the Khasyn River by the Karamken tailings dam outburst causing material damage and human casualties.
